# Manhole Inspection Summary

Manhole # S43E\_\_047MH

Insp Date: **6/9/08 9:10 AM**

**Location** Address: **9 s dallas st**

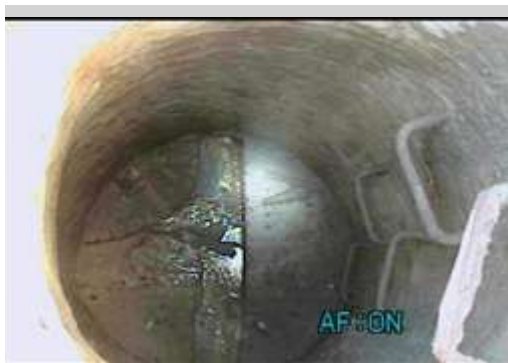
Miscellaneous

bench debris

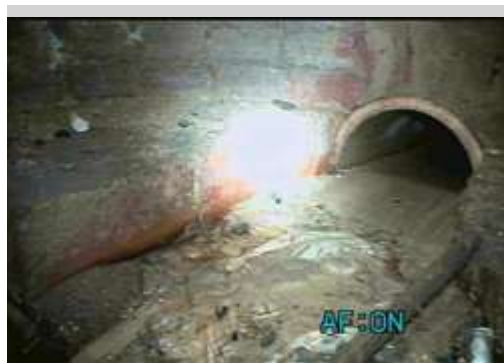
Defect 3

Condition: ☐ Sound ☐ Cracked ☐ Root Intrusion ☐ Deteriorated ☐ Leaks ☒ **Debris**

channel debris

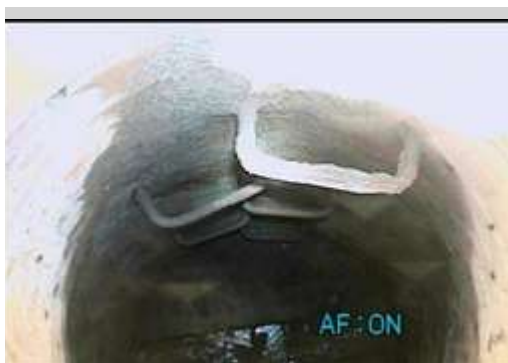
Defect 2

Count: **5** Missing: **1** ☒ **Corroded**

missing/corroded steps

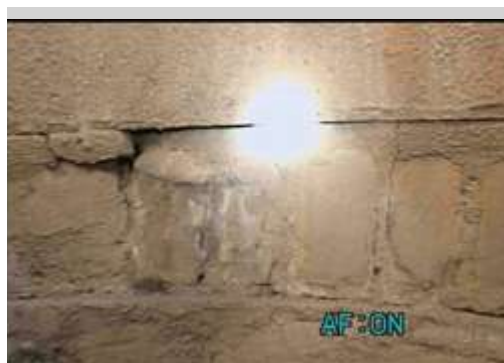
Defect 1

Condition: ☐ Sound ☒ **Cracked** ☐ Root Intrusion ☐ Loose Brick ☐ Deteriorated

Chimney cracked

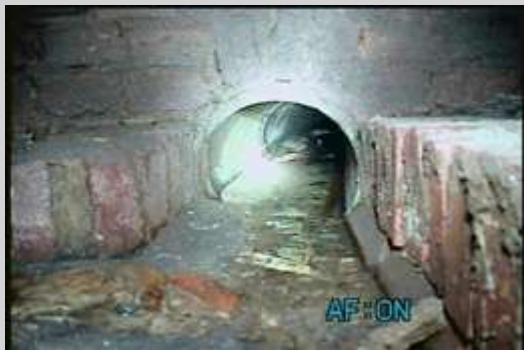
12 O'Clock Outflow

Deposits: ☐ None ☐ Mud ☒ **Sludge** ☐ Debris ☐ Grease

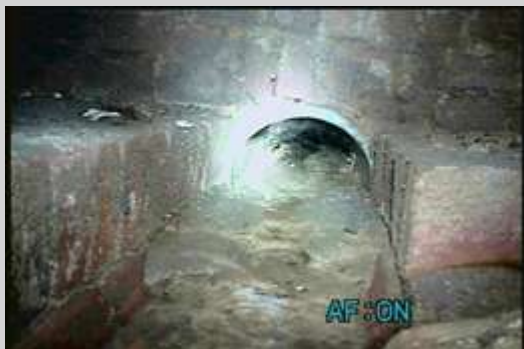
6 O'Clock Inflow

Deposits: ☐ None ☐ Mud ☒ **Sludge** ☐ Debris ☐ Grease

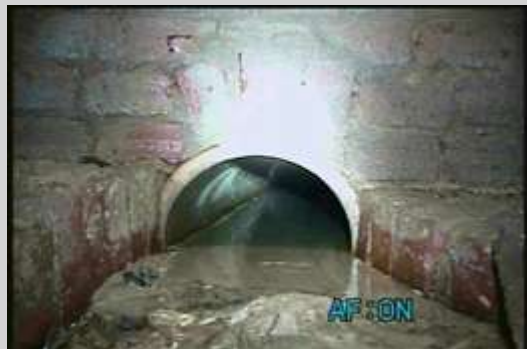
9 O'Clock Inflow

Deposits: ☐ None ☐ Mud ☒ **Sludge** ☐ Debris ☐ Grease
